Mojave Installationsprobleme USB Stick nicht erkannt

Beitrag von „Lukaspa“ vom 3. Dezember 2018, 22:56

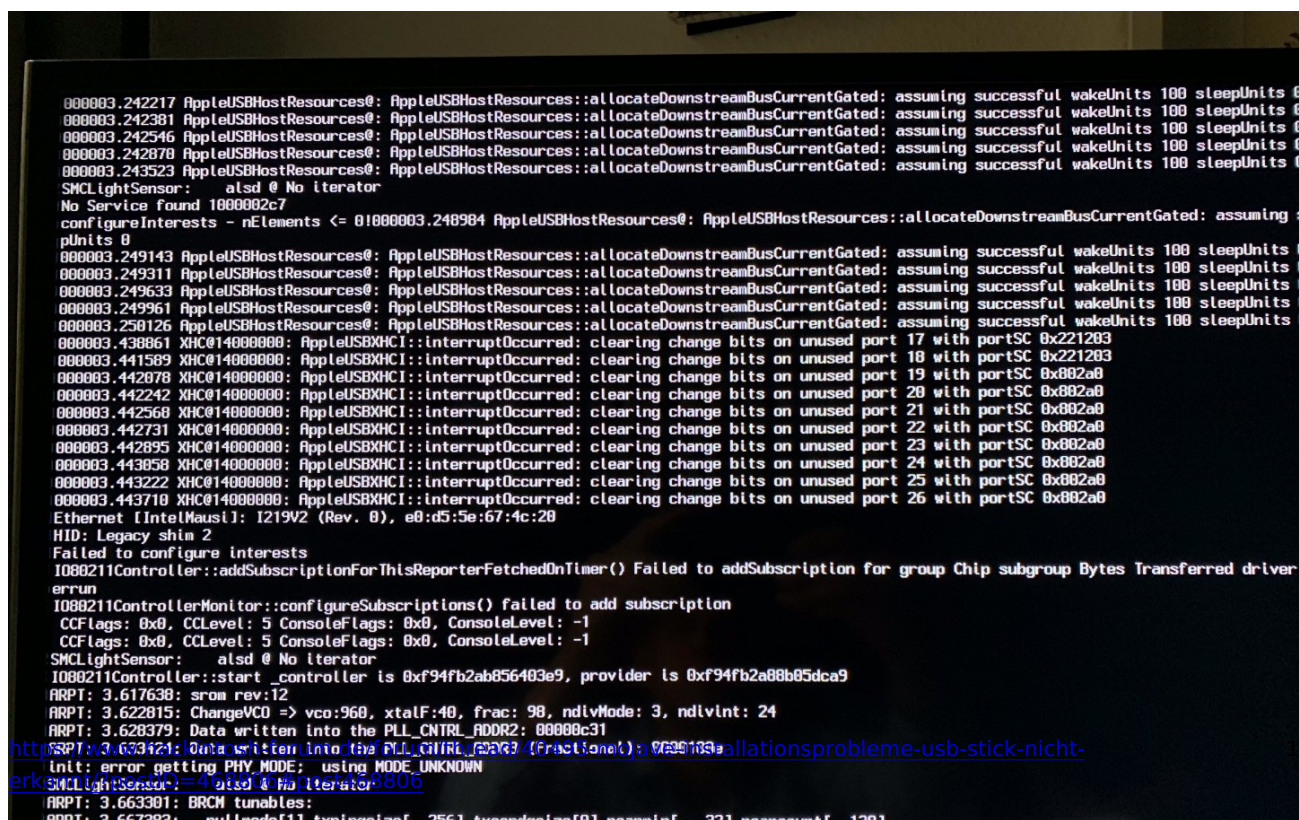
Wenn ich nun die Installation starte, dann gibt es folgende Fehlermeldung.

siehe fotos

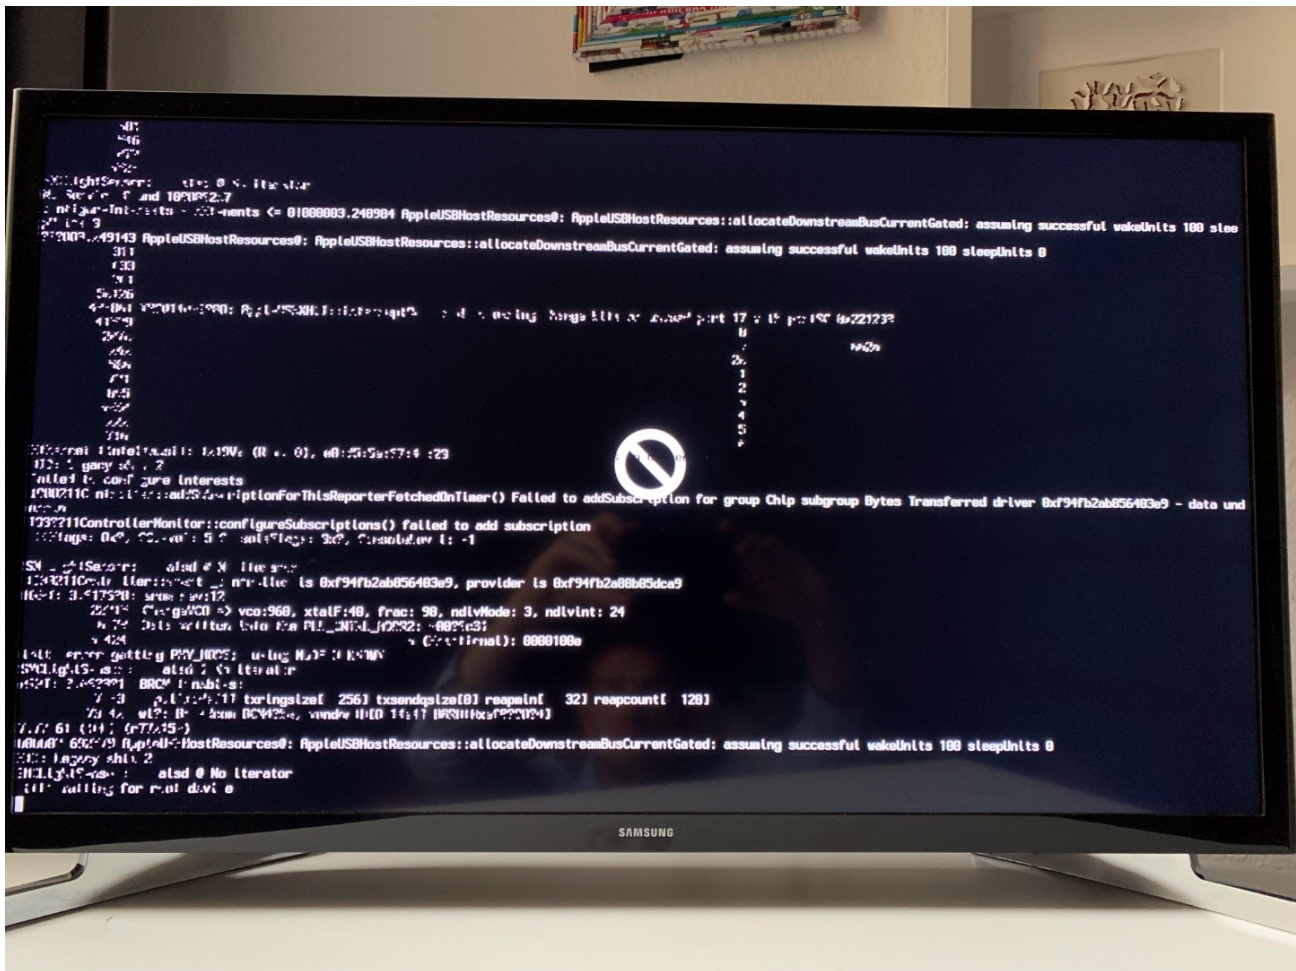
und dann folgt dieses Verbotsschild.
