Sleep-Problem unter Monterey mit Z490-Chipsatz

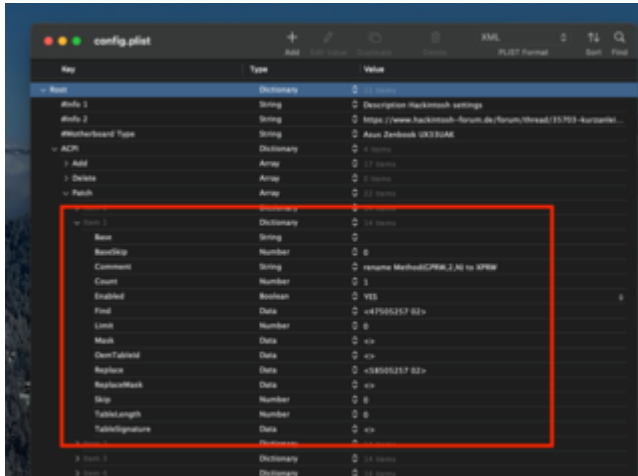
Patch dazu / Muss zur eigenen DSDT passen wo GPRW vorkommt:

7. External(XPRW, MethodObj)
8. External(RMCF.DWOU, IntObj)
9.
10. // In DSDT, native GPRW is renamed to XPRW with Clover binpatch.
11. // As a result, calls to GPRW land here.
