Projekt Asus X99 Deluxe 2 in NEU und OC

Beitrag von „MacGrummel“ vom 23. Februar 2024, 16:40

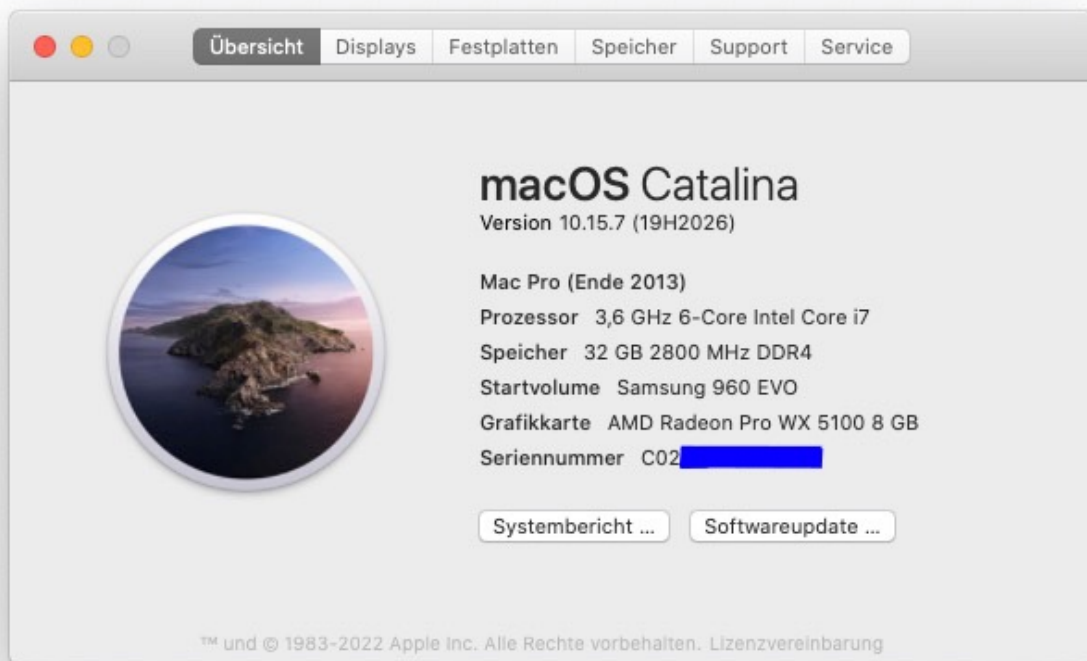
Die vergangenen Tage hab ich versucht, die Festplatten auf einen halbwegs aktuellen Stand zu bringen: die zweite SSD läuft seit ner Woche prima mit Mojave,

die NVMe ging problemlos auf Catalina, aber bei allen höheren Varianten hakt es beim IONVMeController. Oder direkt danach beim allgemeinen VirtualSMC-Sensor SuperIO, den ich unterdessen rausgeworfen habe.

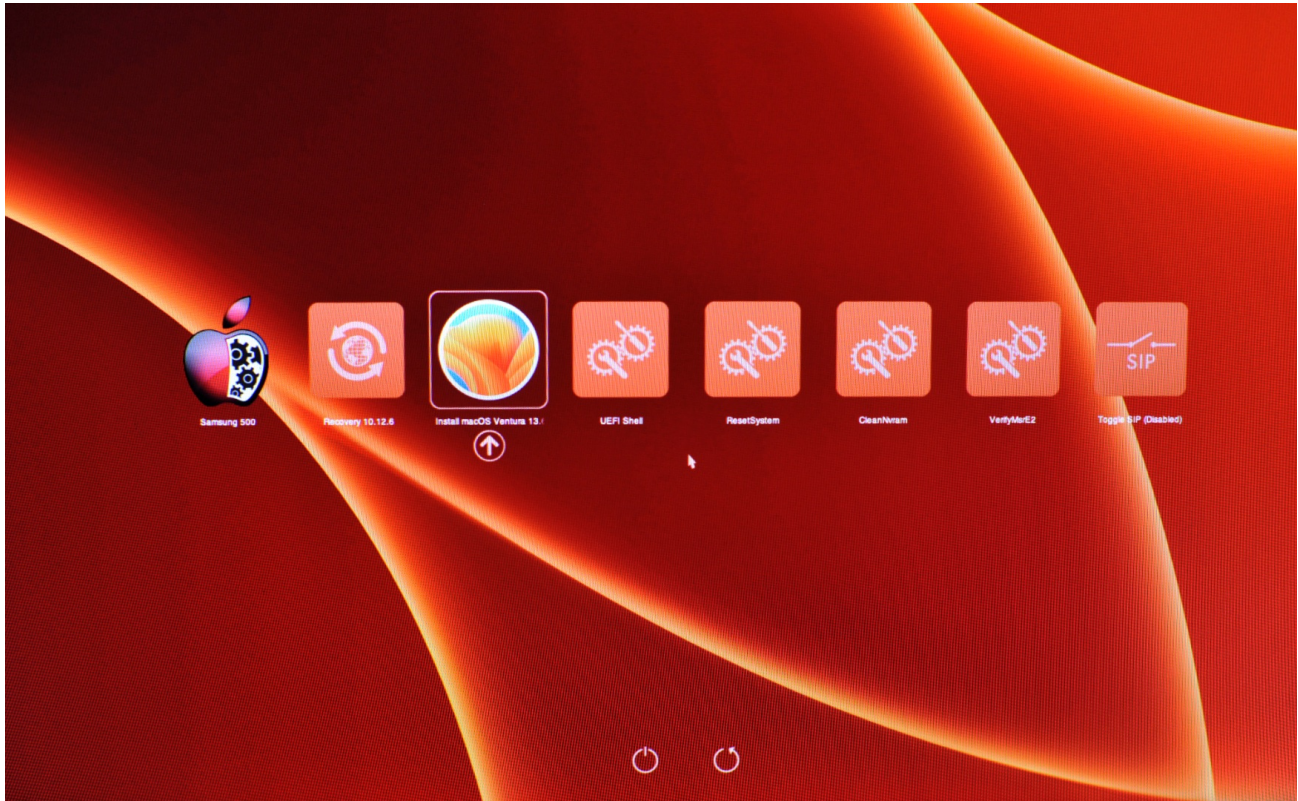
Auch den NVRam zurück setzen hat da bisher nicht geholfen. Besonders originell find ich die Variante, statt der üblichen doppelten -1 für "Any Version" die Zahlen einzutragen, die Sierra ausschließen sollen: es werden nur noch die Sierra-Platte und der Ventura-USB-Installer im Picker angezeigt, der Rest ausgeblendet:
